BY AUTHORITY OF Le Sueur
BY Le Sueur DATE 13 June 47
U.S. ARMY AIR FORCES
REPORT OF AIRCRAFT ACCIDENT

(1) Place Station 139 (2) Date 26 January 1944 (3) Time 1009
AIRCRAFT: (4) Type and model B 17-F (5) A. F. No. 42-3271 (6) Station 139
Organization: (7) Eighth (8) 100th (9) BH (10) 351st (11) BH

SUBJECT: AIRCRAFT ACCIDENT OF JANUARY 26, 1944 INVOLVING ONE B-17 OF STATION 139.

SUBJECT : Inspection of Landing Gear on B17F - 42-3271.
TO : Station Operations Officer, AAF Station 139.

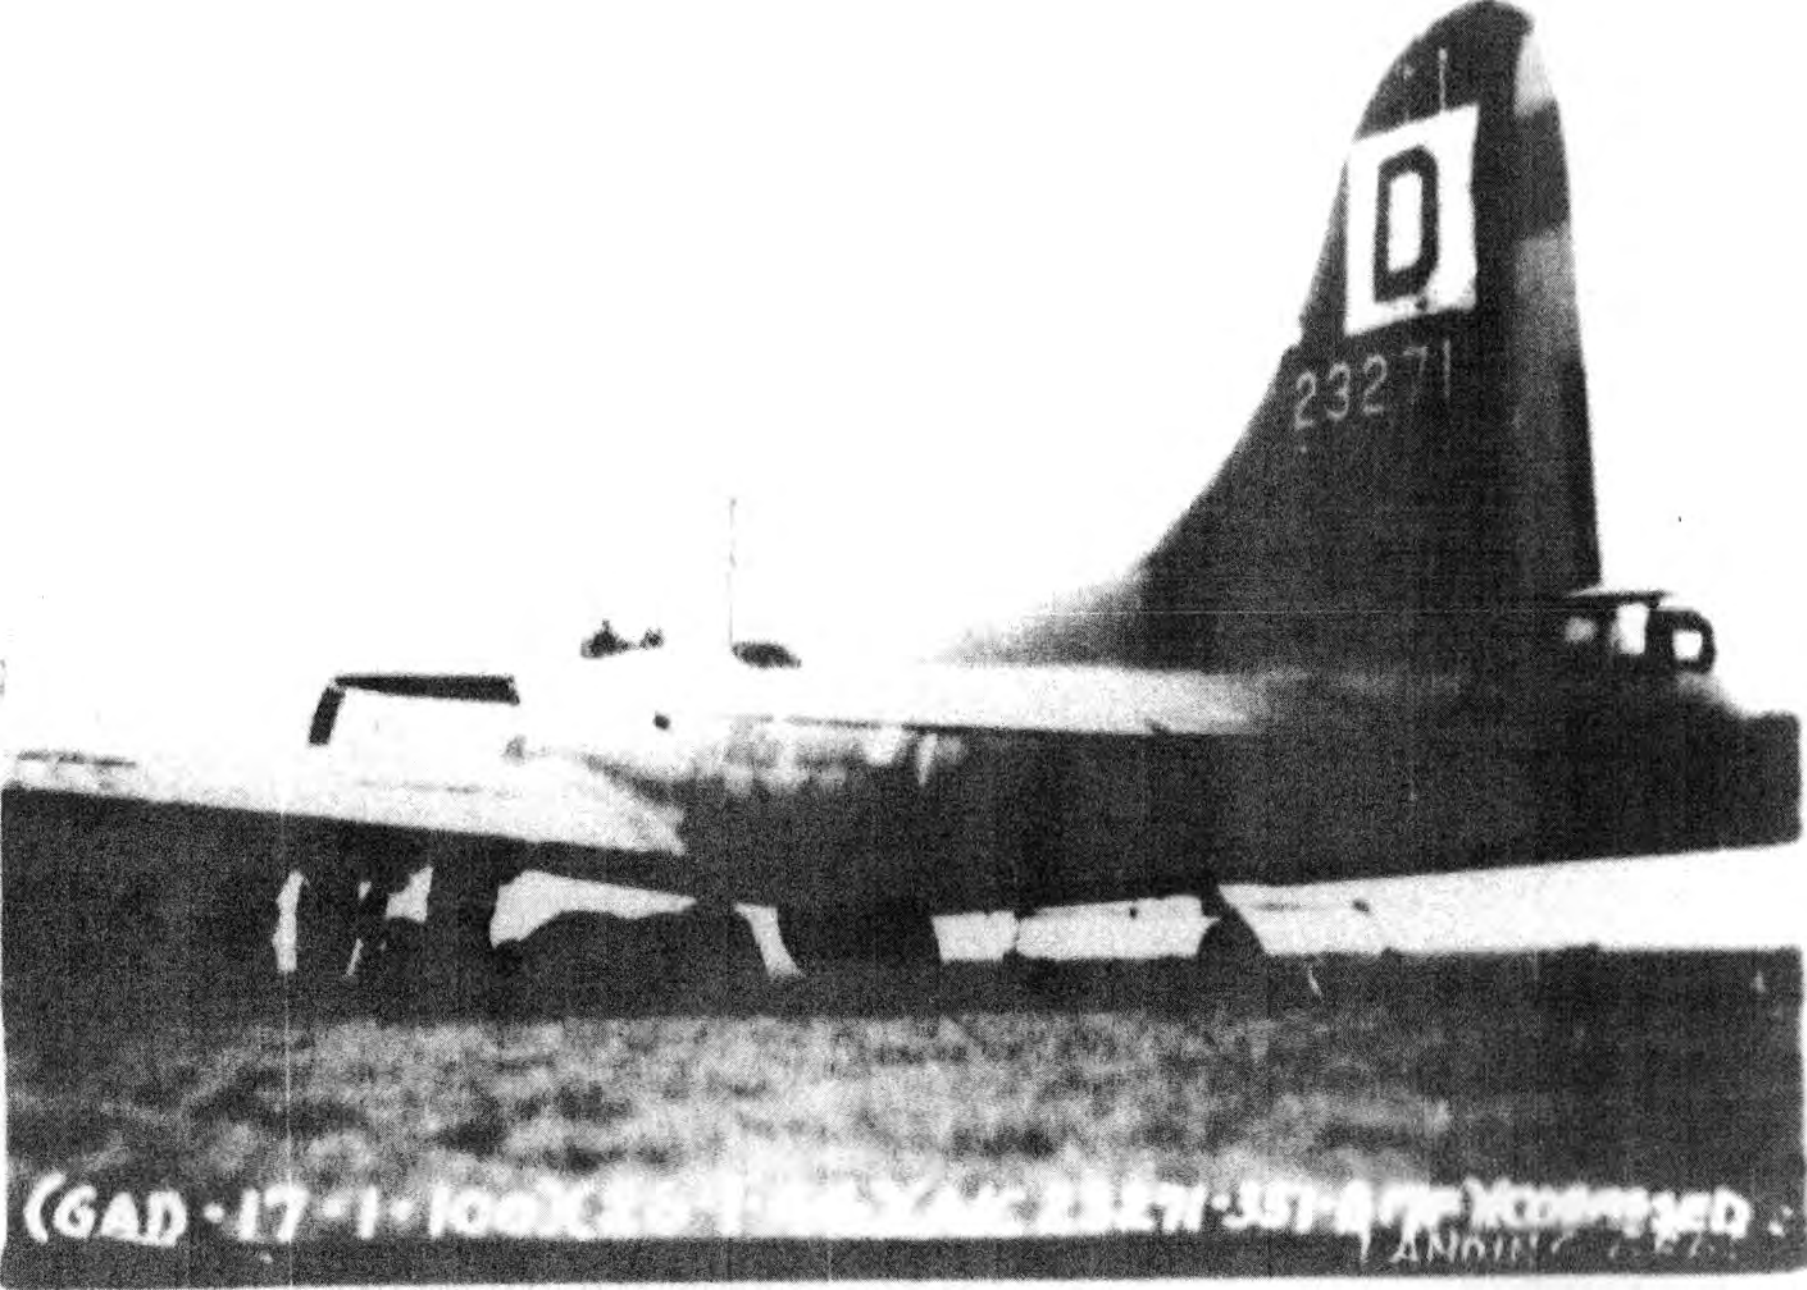
(GAD) - 17 - 1 - 100 X 25 - 100 YAC 23271 - 357 - 8 mm Monopod
LANOIT 1971

1. Inspection of the left hand main landing gear on the above number ship discloses that the retracting screw, part No. 3-15118, broke at the lower limit switch upon landing, resulting in the collapsing of the left hand main landing gear.

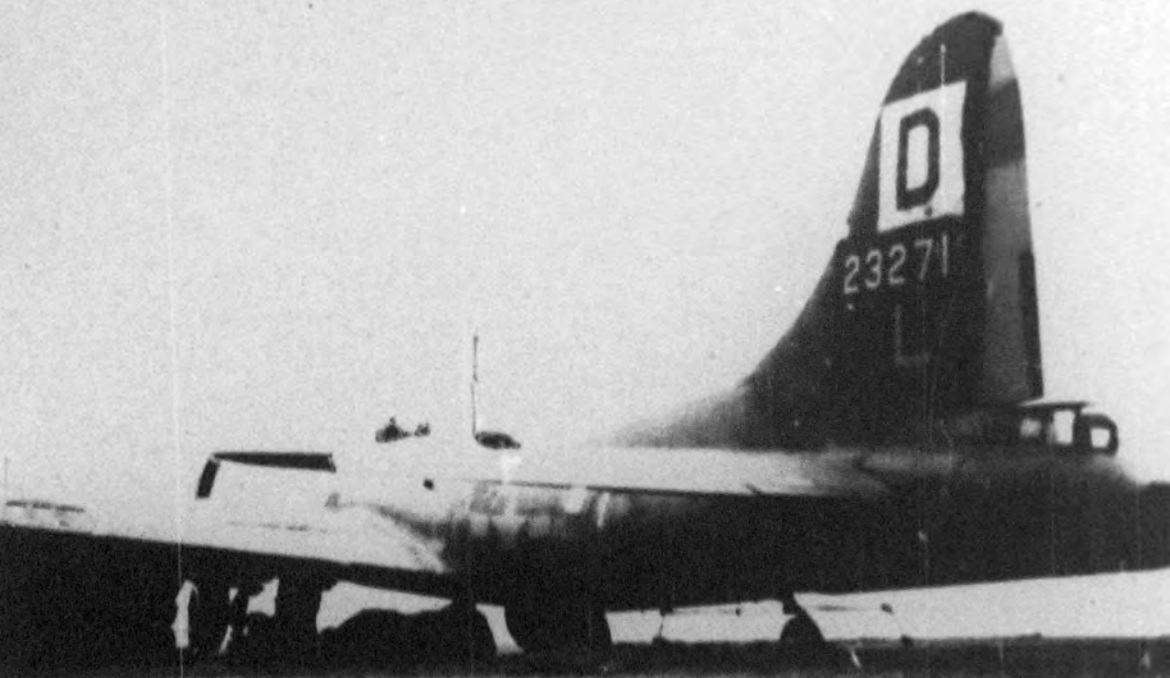
(GAD) · 17 · 1 · 100X20 · 1 · 16 · YAK 23271 · 351 · 877 · Kconesed

Ship No. 42-3271 made a normal approach for landing on runway 28. The pilot leveled out too high and the plane lost flying speed before it could settle in to landing position. As a result it mushed in striking the runway left wheel first. Upon contact with the ground the left retracting screw broke causing left gear to collapse. The pilot applied #1 and #2 throttles in an effort to keep plane straight, but in spite of this action the plane swerved off runway coming to rest on the dirt.
