**RESTRICTED**  
WAR DEPARTMENT  
U. S. ARMY AIR FORCES  
**REPORT OF AIRCRAFT ACCIDENT**

Accident No. 133

(1) Place AAF # 139 (2) Date 21 June 1944 (3) Time 0435  
Aircraft: (4) Type and model B17G (5) A. P. No. 42-37686 (6) Station AAF # 139  
Organization: (7) 8TH AF (8) 100 Bomb Gp (9) 350 Bomb Squadron  
(Command and Air Force) (Group) (Squadron)

(57) Cause of accident Lack of hydraulic pressure caused this aircraft to run into aircraft 42-8010 while taxiing.

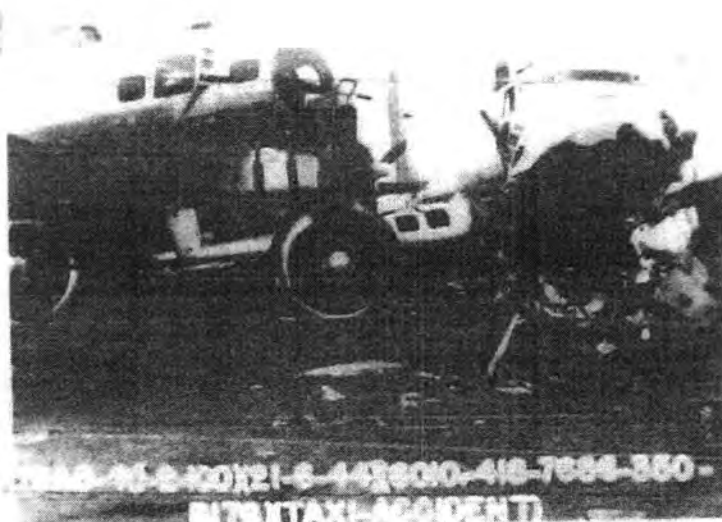
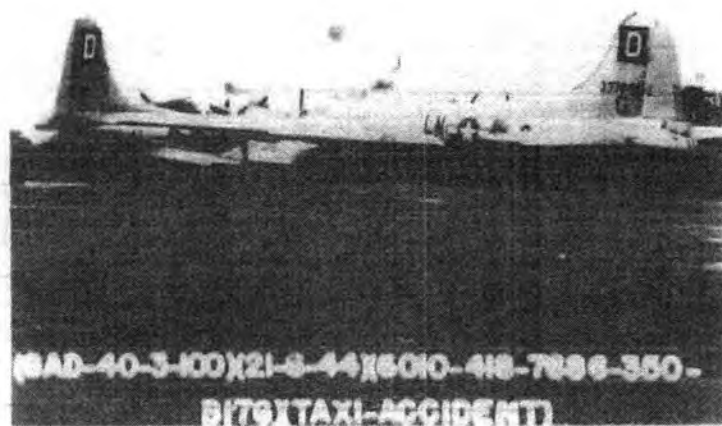
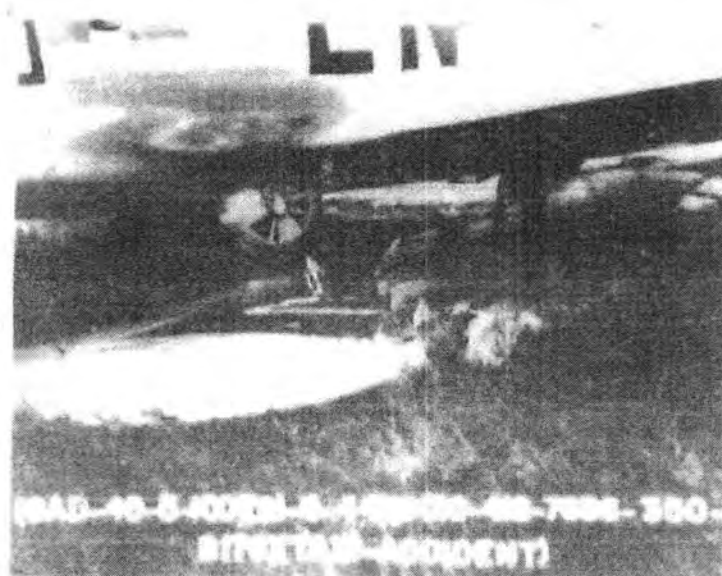
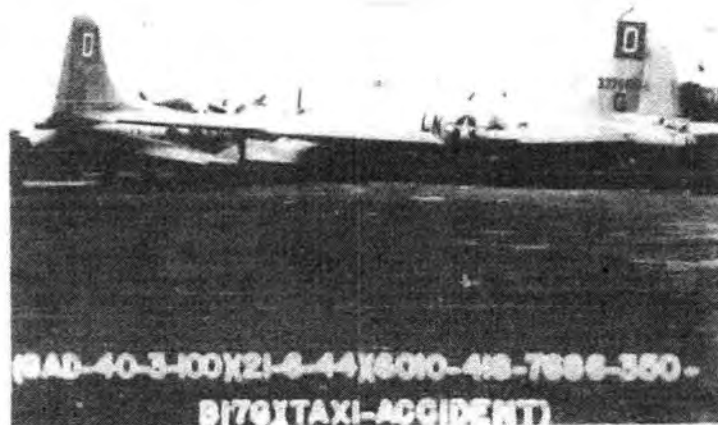
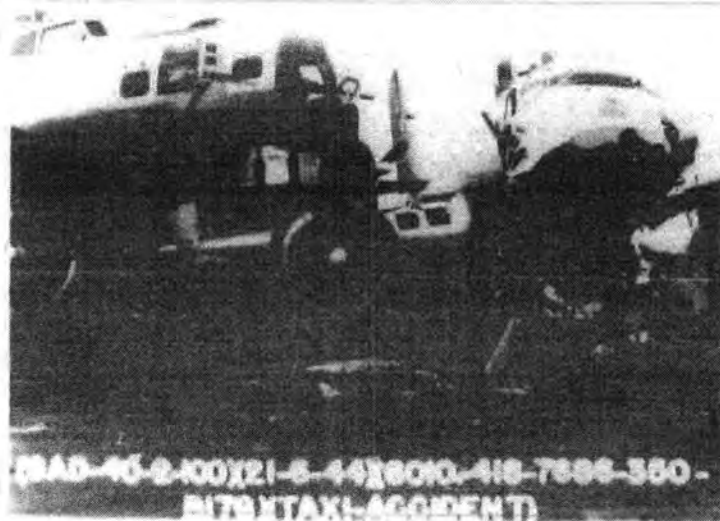
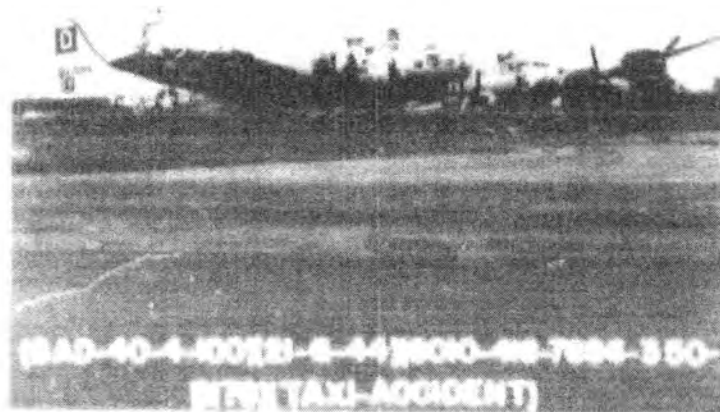
3. Synopsis of Accident: While taxiing around to take-off position for an operational mission, the brakes of 686 G gave way causing aircraft to run off Southwest perimeter track into hardstand #48 where aircraft 010 W was just starting engines. Right wing and #4 engine of 686 G struck the nose section and right wing of 010 W. One engine of 010 W caught fire but crew extinguished it before crash crew arrived.

4. Damage: 010 W - Whole nose section back to wing completely demolished. All of right wing and #3 and 4 engines crumpled. Right landing gear gave away.  
686 G - Right wing torn off down to #4 engine and prop ruined. Left wing tip slightly damaged.
