## REPORT OF AIRCRAFT ACCIDENT

(1) Place AAF STATION 139 (2) Date 29 August 1944 (3) Time 1415  
 Aircraft: (4) Type and model B-17G (5) A. F. No. 43-38043 (6) Station AAF 139  
 Organization: (7) 8th AF (8) 100th (9) 350th (Squadron) Z904  
 (Command and Air Force) (Group) (Squadron)

# DESCRIPTION OF ACCIDENT

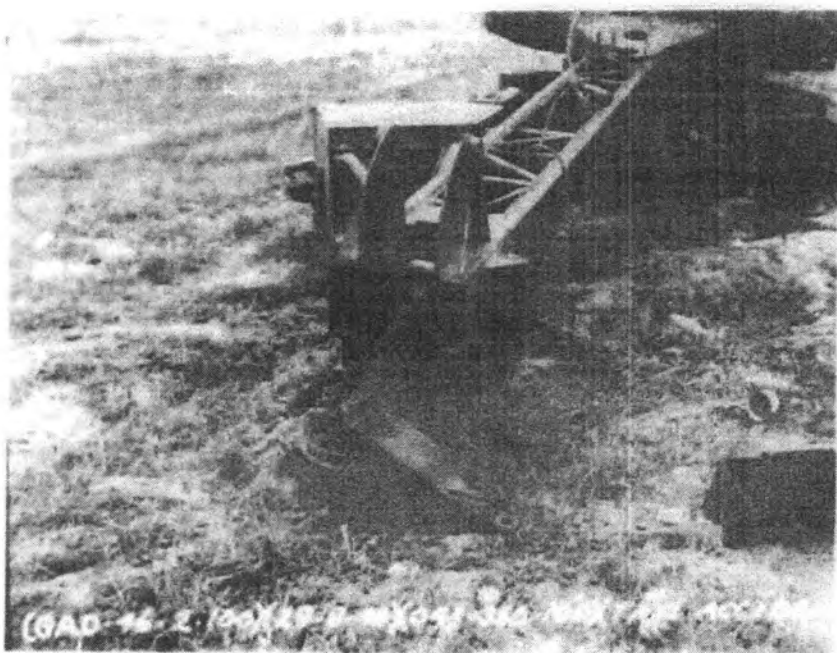
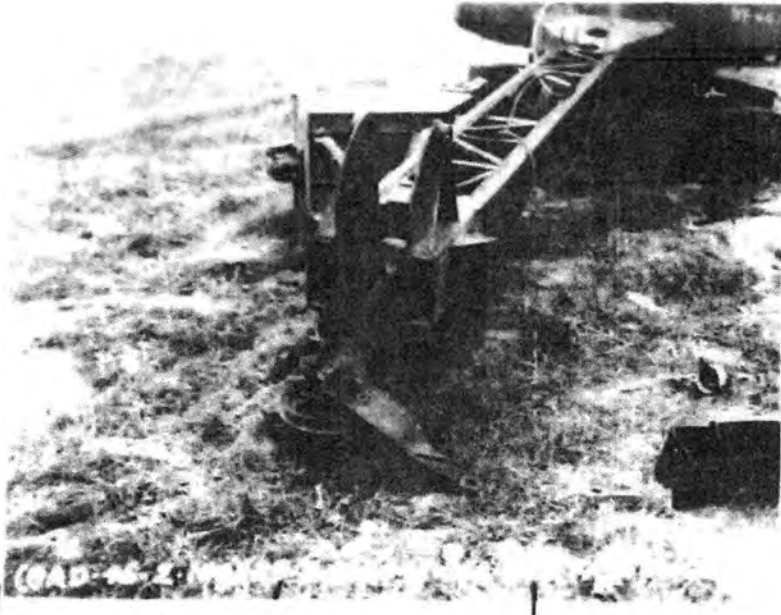
EXHIBIT 7E

| DAMAGE | (43) LIST OF DAMAGED PARTS |
|---|---|
| (46) Aircraft <u>N</u> <u>N</u> <u>N</u> <u>N</u> | Right wing tip torn off |

(56) Nature of accident Taxiing accident. Aircraft taxied into obstruction on perimeter strip

(57) Cause of accident Negligence of Pilot, Copilot and operator of civilian power shovel.

3. Action to prevent recurrence: (a) Repeated instructions to all pilots and copilots to taxi slowly and carefully; (b) Additional inspections by Flying Control personnel of the perimeter and runways as per the attached letter marked Exhibit "A".
