# REPORT OF AIRCRAFT ACCIDENT

(1) Place Station #13 (2) Date 21 November 1944 (3) Time 1730  
 AIRCRAFT: (4) Type and model B17G DO (5) A. E. No. 42-38047 (6) Station #139  
 Organisation: (7) 8th (8) 100th (9) 351st  
 (Command and Air Force) (Group) (Squadron) 2904

(56) Nature of accident **Landing accident**

(57) Cause of accident Structural failure of belt joining drag strut to drag support and/or structural failure of drag link.

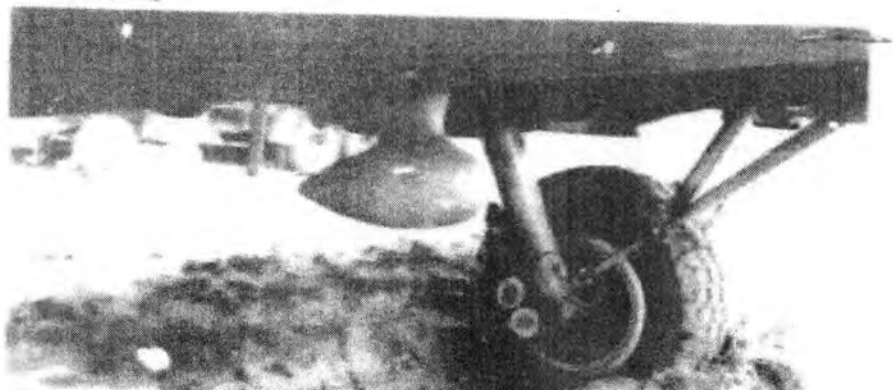
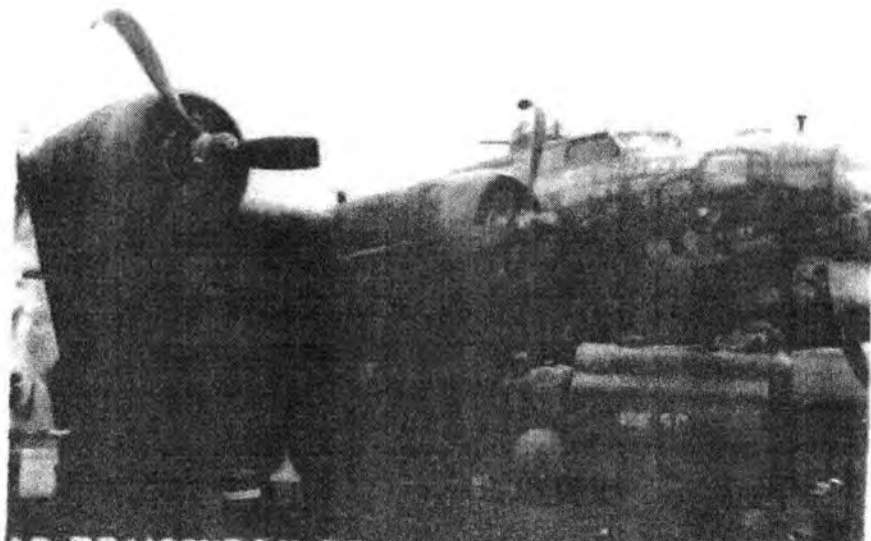
AD-55100124-142047-8177(TAXI-ACCIDENT)

3. It is believed that the material failure occurred in the following sequence. The inboard bolt (drag strut to drag support) failed in shear, allowing severe vibration of drag strut assembly which in turn caused the failure of the drag link. This allowed the collapse of the gear and subsequent ground looping the plane.

a. On the evening of 21 November 1944, the right landing gear of B-17G airplane # 42-38047 collapsed as the plane was completing its roll. Investigation revealed that the drag strut to drag strut support, inboard upper attaching bolt, failed in shear. This allowed severe vibration of the drag strut assembly causing the subsequent failure of the drag link. Enclosed photograph shows failure of both parts. It is believed the failure was sudden and due to the hard landing rather than a gradual failure such as metallic fatigue.

a. It is difficult to state any further recommendations than those already accomplished in T.O. 01-20E-111 which recommends the replacement of the drag link with one of stronger design and T.O. 01-20E-118 which replaces the upper inboard 3/4" bolt (AN-32-54) with an AN 34 bolt which is 7/8" in diameter.
