REPORT OF AIRCRAFT ACCIDENT

(1) Place Alconbury, England (2) Date 15 September 1945 (3) Time 1327  
Aircraft: (4) Type and model B-17D (5) A. F. No. 44-8719 (6) Station AAP Sta 139  
Organization: (7) 8th Air Command (8) 100th Bomb (9) 350th Bomb (10)   
(Command and Air Force) (Group) (Squadron)

UNSATISFACTORY REPORT

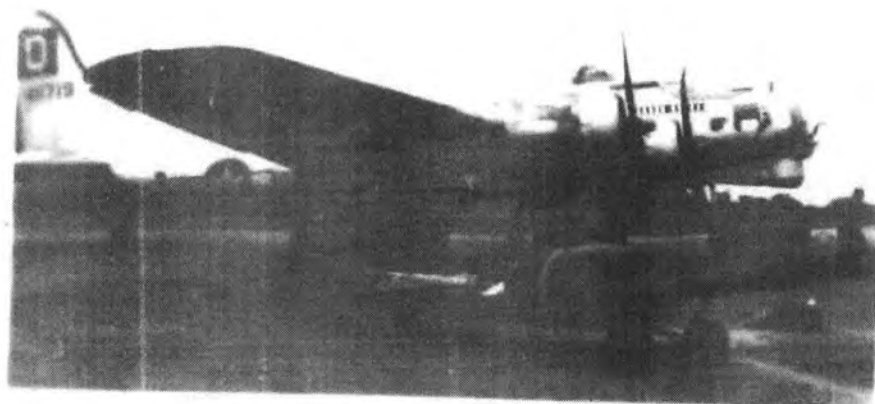
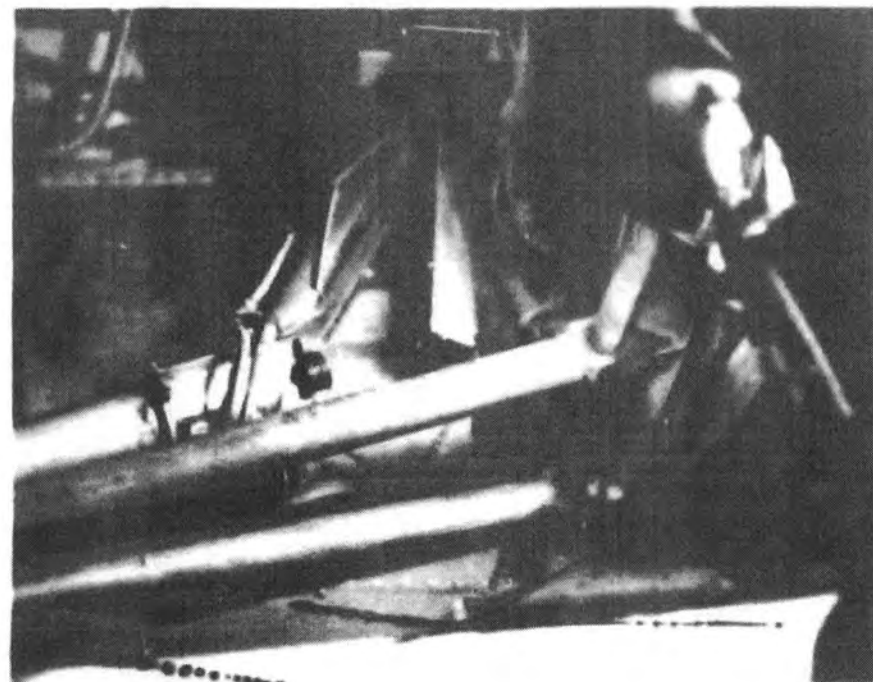
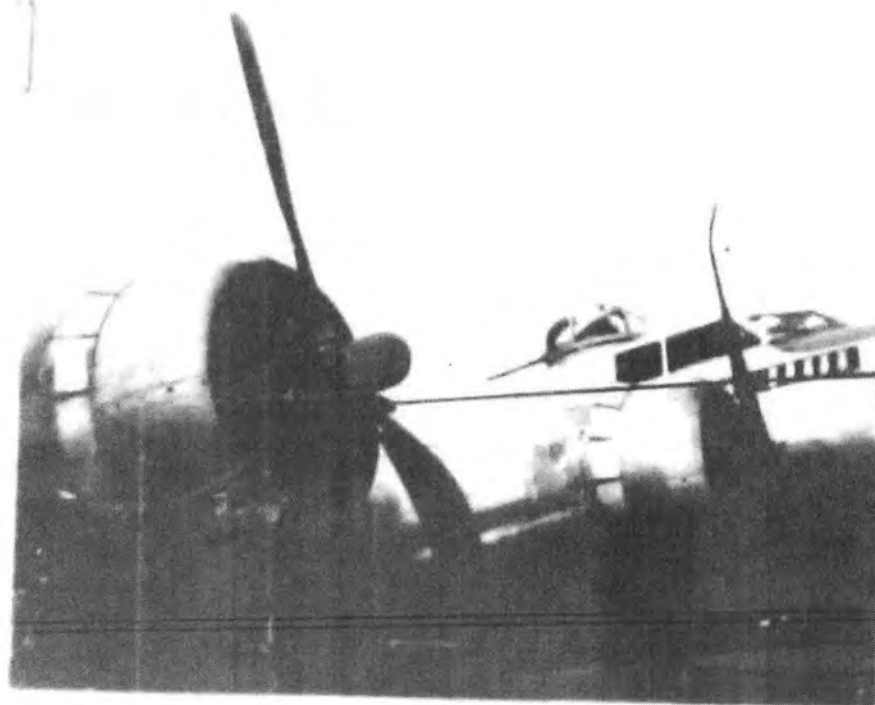
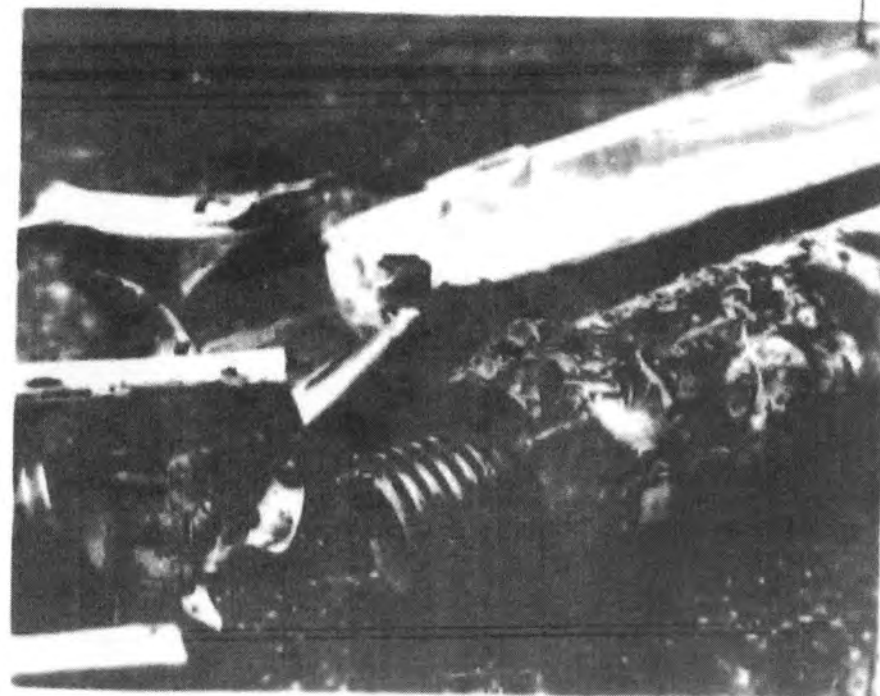
(57) Cause of accident Landing gear Collapsed due to material failure.

2. Upon inspection, it was found that the actuating screw of right landing gear retracting mechanism was broken, due to material failure.

Subject aircraft made a normal landing at AAF Station 102, APO 557, on 13 September 1945. When it was nearly at the end of its roll, the right landing gear collapsed. Upon inspection it was found that the actuating screw (Part No. 0108-3-15118), of right landing gear retracting mechanism failed. Cause of this failure is believed to have been previous abnormal landings, or a metallic failure.

That a more thorough check be made at the factory.
