BY AUTHORITY OF Le Sueur
BY Le Sueur DATE 13 June 47
U.S. ARMY AIR FORCES
REPORT OF AIRCRAFT ACCIDENT

(1) Place Station 139 (2) Date 26 January 1944 (3) Time 1009
AIRCRAFT: (4) Type and model B 17-F (5) A. F. No. 42-3271 (6) Station 139
Organization: (7) Eighth (8) 100th (9) BH (10) 351st (11) BH

SUBJECT: AIRCRAFT ACCIDENT OF JANUARY 26, 1944 INVOLVING ONE B-17 OF STATION 139.

SUBJECT : Inspection of Landing Gear on B17F - 42-3271.
TO : Station Operations Officer, AAF Station 139.

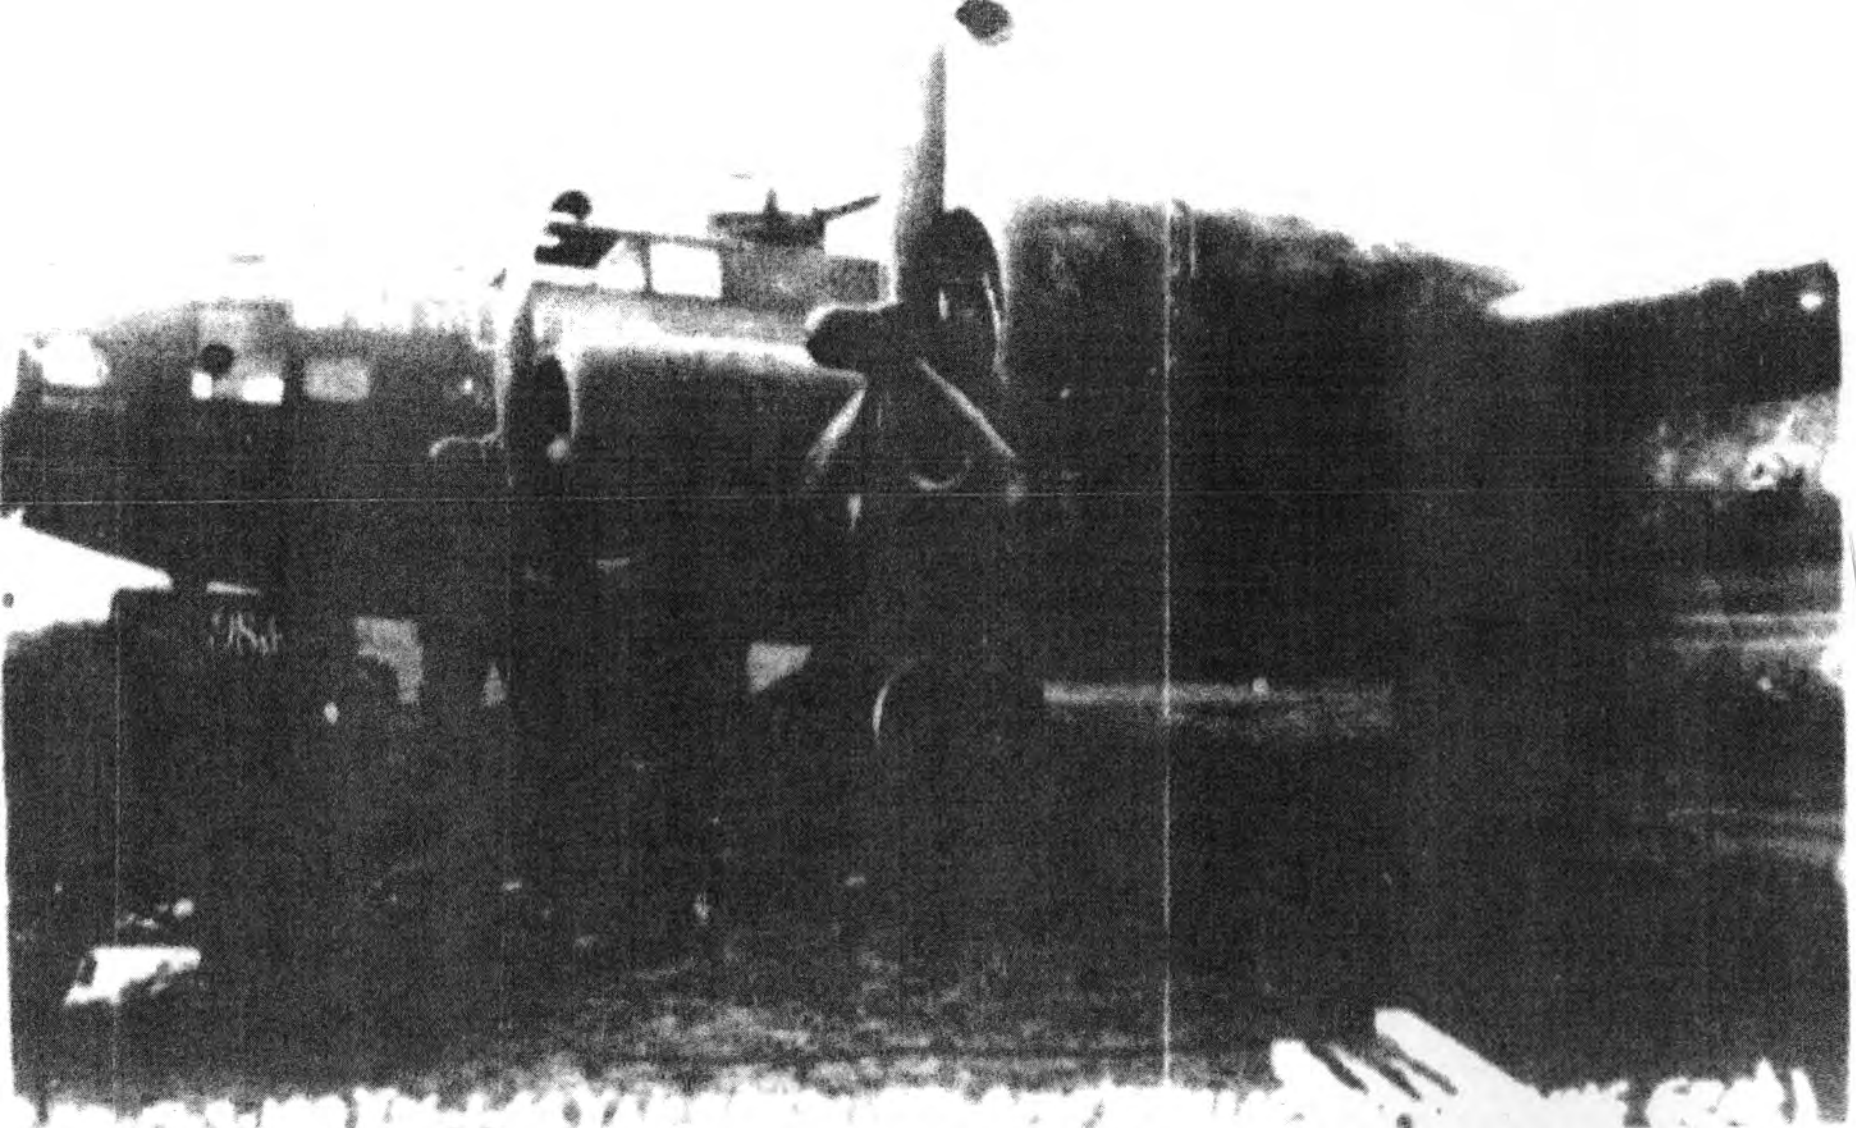
CAB-17-2-100

(55) Cause of accident
1. Pilot underestimated stalling speed of heavy ship.
2. Left main retracting screw failed.
(56) Nature of accident Aircraft stalled on final approach.

It is impossible to determine whether the prime cause of this accident was because of the landing or mechanical failure, or a combination of the two.
